#### INSPECTING METAL PIPE & PIPE-ARCH

# Commentary to aid inspection of Steel & Aluminum Pipe & Pipe-Arch conforming to Section 02610 of the UDOT Specifications

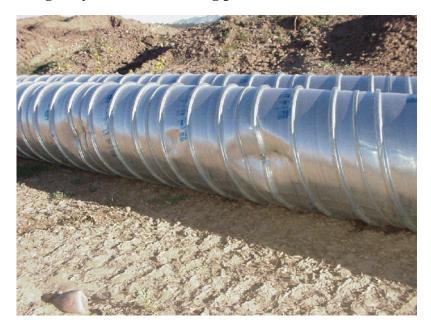
Reject any pipe damaged by careless unloading practices.

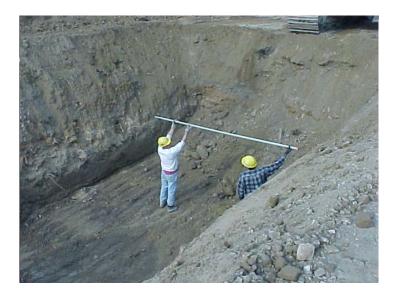
## Note that unlike plastic pipe metal pipe can use both a trench installation or can be installed simultaneously with the embankment.

Hint: Measure trench width at the crown (top) of the pipe.

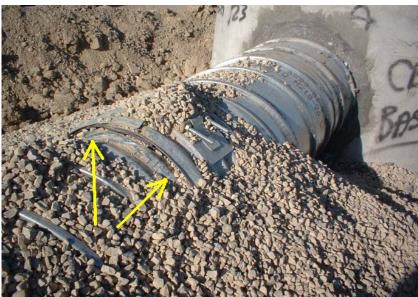
Examples of joints that should be rejected. The photo on the left shows gap in the annular space where nonshrink grout was not used and a gap has formed which will cause leakage. The photo on the right shows gravel "sandwiched" beneath the gasket material destroying the seal. Water will leak from the joint and flow through the gravel and saturate the subgrade.

Hint: These joints are easily repaired if caught before backfill is in place. They are difficult and expensive to repair later. These joints will easily fail the leak tests found in 02610. Do the Contractor a favor and point them out as soon as possible.

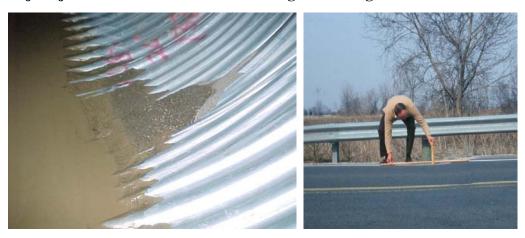
All irrigation pipe & storm drains should be water tight under normal conditions. Similarly all cross culverts are required to be soil tight & silt tight. Evidence of leakage or the piping of fines is a reason to reject such pipe. The photo on the left shows fine sands being washed into the pipe through a faulty joint causing a dip in the pavement above.

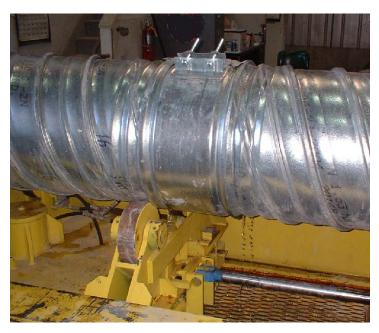
Remember that *ALL* storm drains & *ALL* irrigation pipe must have joints that will pass a 5-psi pressure test (or meet even stricter pressure requirements if specified in the plans).

Cross culverts must have joints that will pass a 3 psi pressure test in the laboratory.
